DTG Viper Error 00010004

The Error Code 10004 means that for some reason the CR Encoder strip cannot be read correctly by the Carriage Encoder sensor. Things that can cause this are:

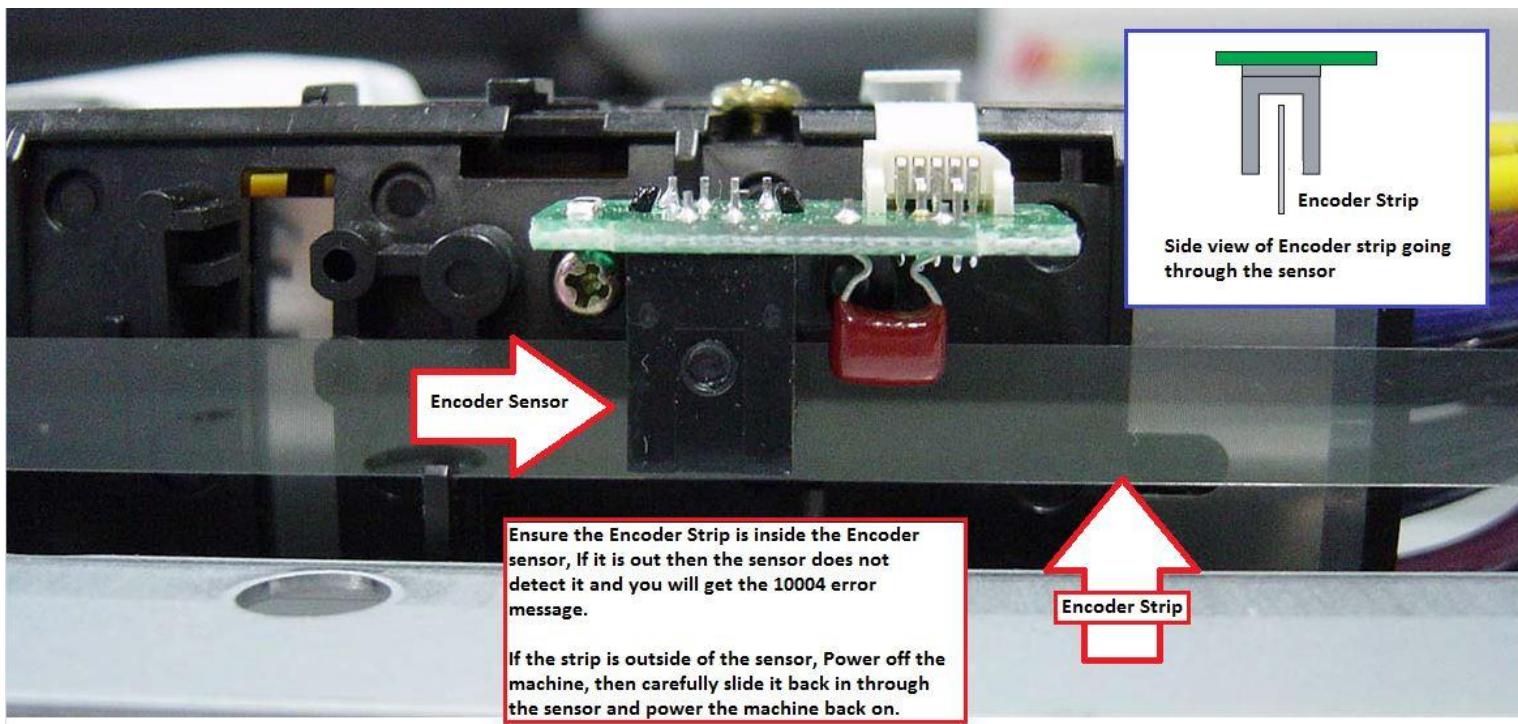
Dirty or scratched encoder strip or encoder strip is not seated in the sensors slot:

Power off the printer and manipulate the encoder strip so it is in the slot of the sensor then power back on to see if it is being read. Also get a close look at the encoder strip and if there is any debris on it, clean it carefully with some Isopropyl alcohol and power on and see if the error clears.

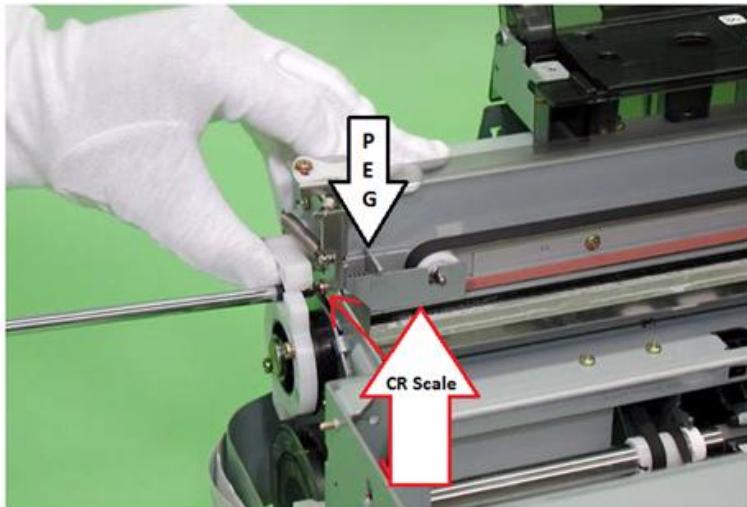
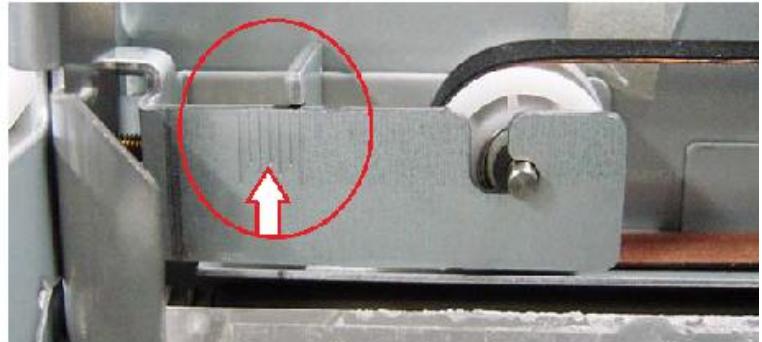
Loose CR Belt Tension.

On the right side of the printer (Emergency stop button side) there is a CR Belt tension scale, Make sure this Peg is set to the middle bar of the scale.

Adjust the Belt tension so the Peg is in the middle of the scale

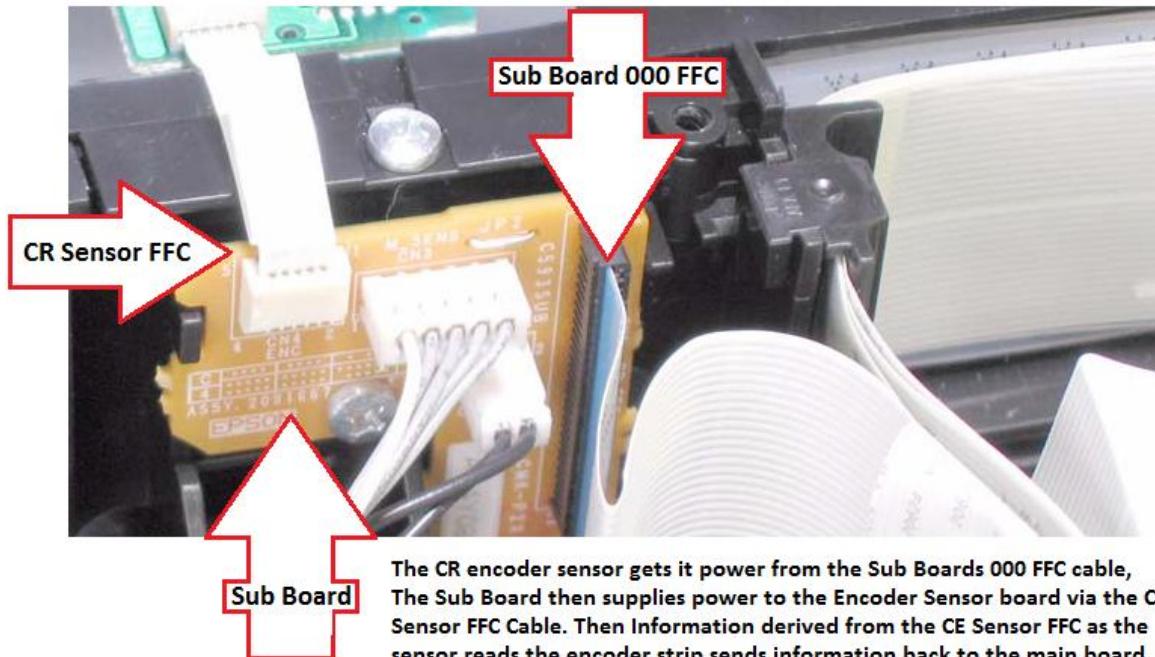
No power from CR Encoder Sensor FFC Cable

The Encoder strip is read from the CR Sensor, and if the CR sensor does not have any electric power from the Sub board then this will also cause the 00010004 Error message. Check the narrow FFC Cable that there is no overspray of ink on it and that it is not damaged at all. Also the Sub Boards 000 FFC cable shown in the image below usually needs to be disconnected during Damper replacement or Print Head replacement. So if you did perform any of these functions, you may want to check this connection.

If your fingers touched the Metal Tabs on the leading edge of the 000 FFC cable (this FFC is labeled 000) then some oil from your fingers or sweat can have transferred to those metal tabs and so no power or signaling from the small narrow FFC cable can be transmitted to the main board for monitoring. So with power off and unplugged, you should carefully disconnect this 000 FFC cable and clean the metal tabs with some 70% Isopropyl alcohol and then carefully dry with paper towel. Also inspect the metal tabs to see if any were bent on the initial connection back into the Sub Board.

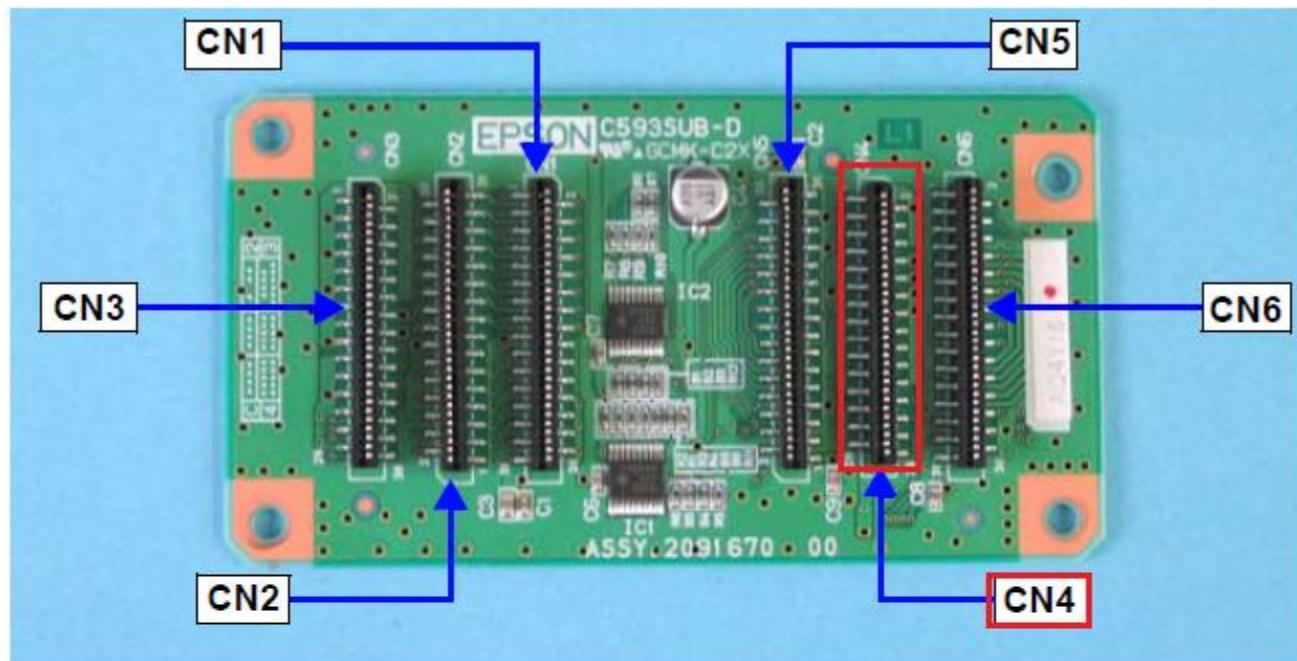
SUB-D Board Connector Positions

If you have just replaced the ribbon cables to the print head, then the connection CN4 on the SUB D board which carries the signal from the CR Encoder sensors FFC and Sub Board FFC cable to the main board may not be inserted correctly or if the metal tabs on the edge of the ribbon cables were touched or if any of the metal tabs were accidentally bent during initial replacement, then this too will interrupt the communication from the CR Encoder Sensor to the main board. If so disconnect and clean the metal tabs gently with 70% Isopropyl alcohol and fix any bent metal tabs.

Signal transferred to Main board CN1 to CN7 on Main Board

Signal from Sub Board through 000 Cable CN4

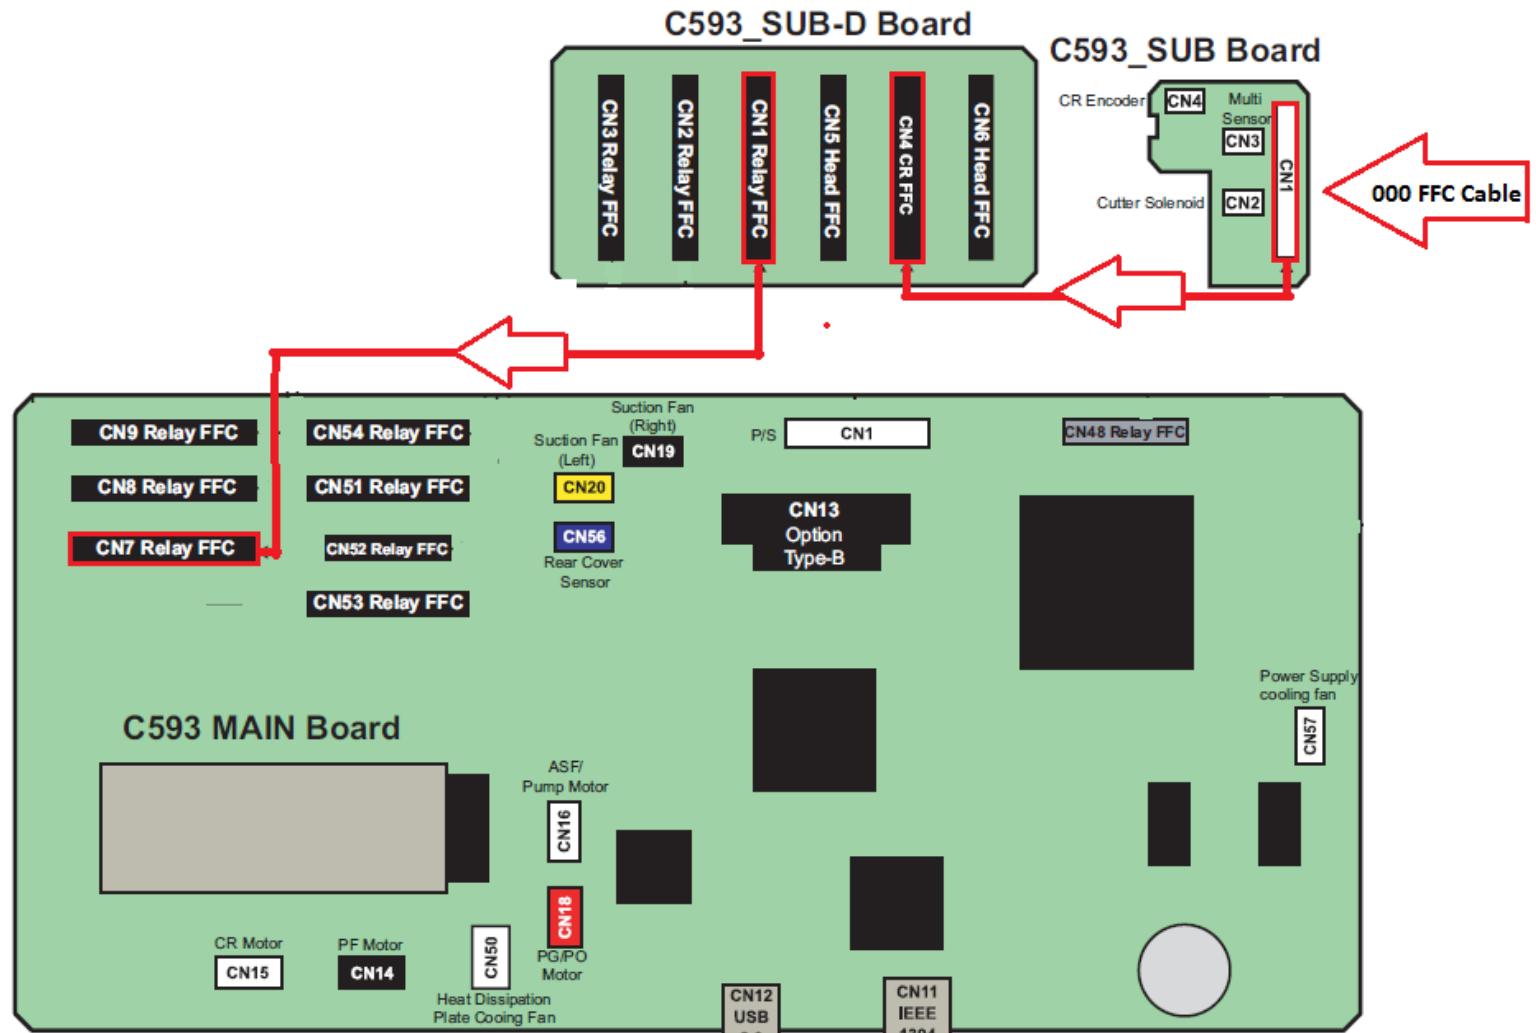
Check Connection On Main Board

Communication goes from the Encoder Sensor via the Small FFC to the Sub Board then carried to the Sub D board via the 000 FFC cable, then from the Sub D to the Main board CN7. If the lower Head Cables were replaced, then you will want to check that CN7 is secured without damage to the FFC cables metal tabs, and if you accidentally touched the metal tabs during installation of the FFC Cable then you will want to clean them with 70% Isopropyl alcohol.
