Error SP-Unit Fix Error 06

Error SP-Unit Fix Error 06 indicates that the color change is not at the correct position. The color change mechanism may have shifted during shipment or moving the machine and now the machine recognizes that the Press Units are not lined up to the working position.

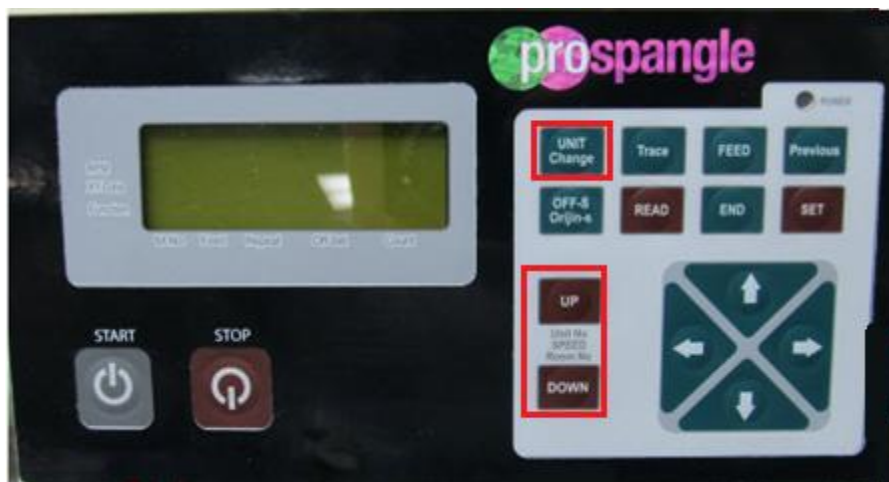
3) Now perform color change by going to UNIT CHANGE and use the speed up to set the Unit to 2 and press the SET button. The machine should color change automatically to Press Unit #2, Press UNIT CHANGE again and use the SPEED DOWN button to set it to 1 and press SET and confirm the machine color changes to Press Unit #1.

```
-- ASP Main Menu --  
SP Unit Change MODE  
SP Unit No = 2  
Previous to EXIT
```
