Spangle Mis Cuts & Out of Round Cuts

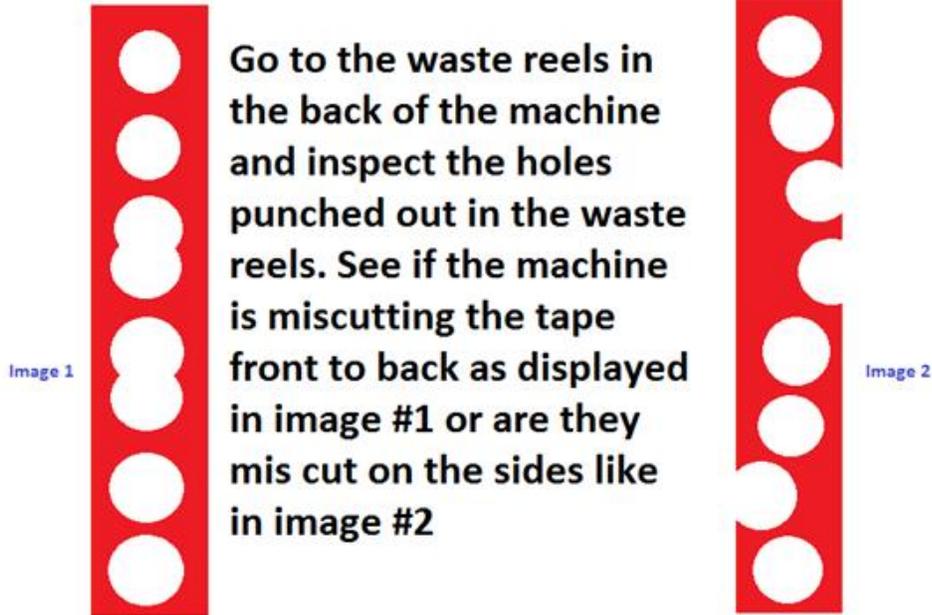
Crescent moon cutting can be caused by a few possibilities. First we have to know in which way the spangle tape is being mis-cut. Going to the rear of the machine and unwinding some length of the waste reel and inspecting the mis-cuts, they will reveal either a left and right mis-cut, or a double cutting front to back on the tape (See image below)

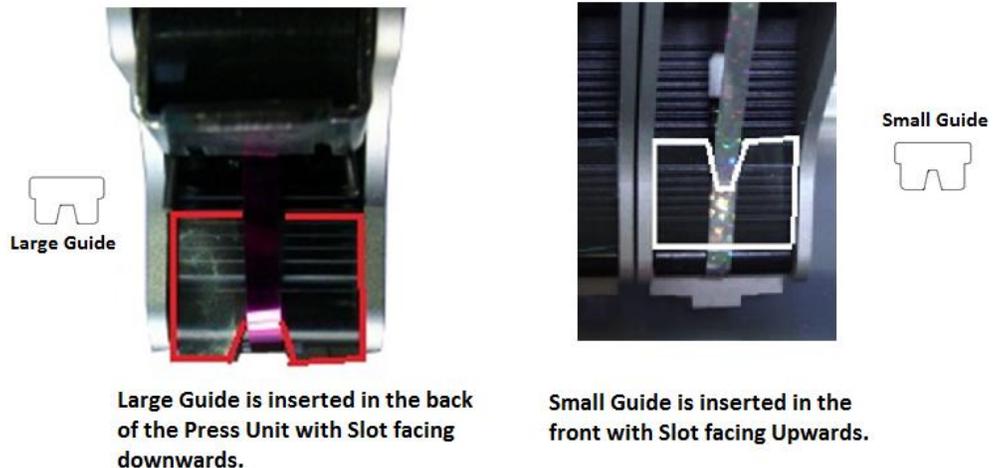
Feeder Guides are used to ensure the Spangle tape that is being fed through the Press unit does not shift side to side which can cause partial mis-cuts of the spangle side to side as shown below. Ensure that the Guides are in place on the front and the back and that the guides are straight and not at an angle.

The front plastic guide is inserted with the slot facing upwards where the back plastic guide is facing downwards.

If spangle tape is mis-cutting side to side, check to ensure the Plastic guides are inserted straight and that the spangle tape is correctly interfacing with the guides to disallow the spangle from moving side to side which will cause the spangle tape to be cut from its side.

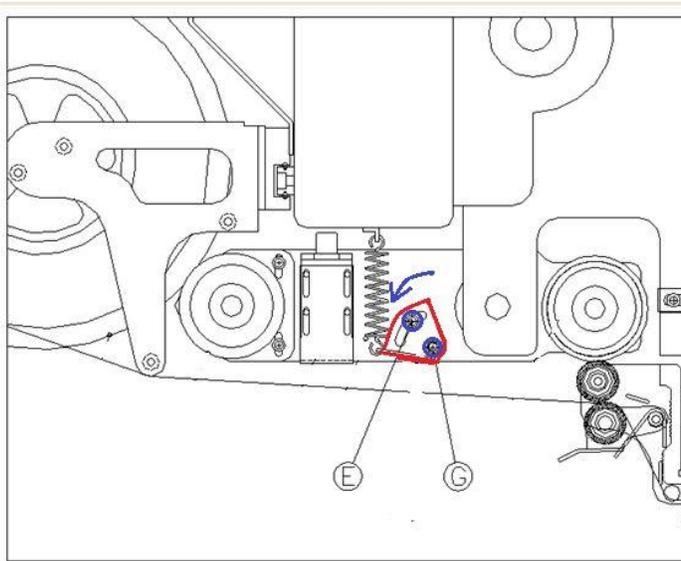
Color change to Unit #6 to gain better access to the Tension Spring Adjustment.

Place you thumb on the tension plate (Outlined in Red)

- 1) Loosen the two 3mm Allen Screws slightly
- 2) Lower the tension plate by about 1.0mm and Re-tighten the Allen Screws.

Tension plate will be difficult to depress as there is a spring holding it up, Use 2 people if necessary, one to depress the tension plate changing it 1mm at a time and the other to tighten the Allen screws.

There is a spring attached to the feed motor to apply tension to the feed rollers on the back of the press unit, if the spring is too loose then not enough pressure for the feed rollers to move the spangle through to the waste reel. Grab the Allen Wrenches from the tool box provided and Press UNIT CHANGE and dial up to change to #6 (This will make it easier to access the tension spring to adjust it).

When adjusting the tension spring plate, Only adjust $1/8^{\text{th}}$ at a time and test to see if mis-cuts has been resolved. If necessary adjust another $1/8^{\text{th}}$ at a time until cuts are circular.

Re-adjust by 1.0mm if necessary until the spangle cut correctly.

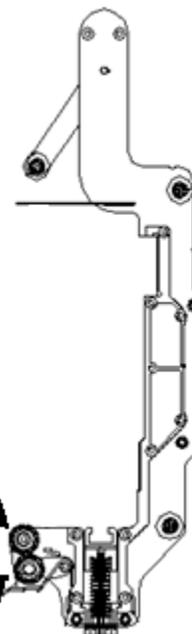
Spangles Mis-Cutting front to back and double cutting.

With the Press Unit mounted with your spangle tape, Roll the Metal roller and see if the spangle tracks center as it comes through.

If not check to ensure the right Plastic Guides are mounted correctly,

And check the levelness of the Rubber roller with the metal roller

Metal Roller

Rubber Roller
