SWF: Error #300

What is the error #300 and how to clear it?

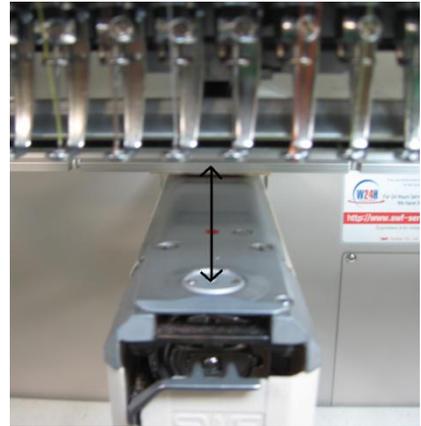
For some reason the Head or Needle Case is not aligned with the needle plate.

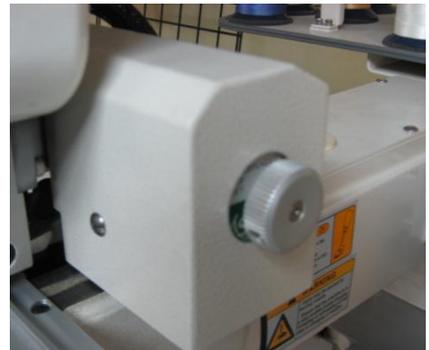
You can use the Passivity Knob that you see in the picture to the right to correct the error by rotating the knob clockwise or counterclockwise until you can align the needle with the hole on the needle plate.
